**Research Project 433 - Final Report**

**The Deployment of Liferrafts Carried on UK  
Registered Fishing Vessels - Phase 1**

**Report No. 1442/1**

**January, 1999**

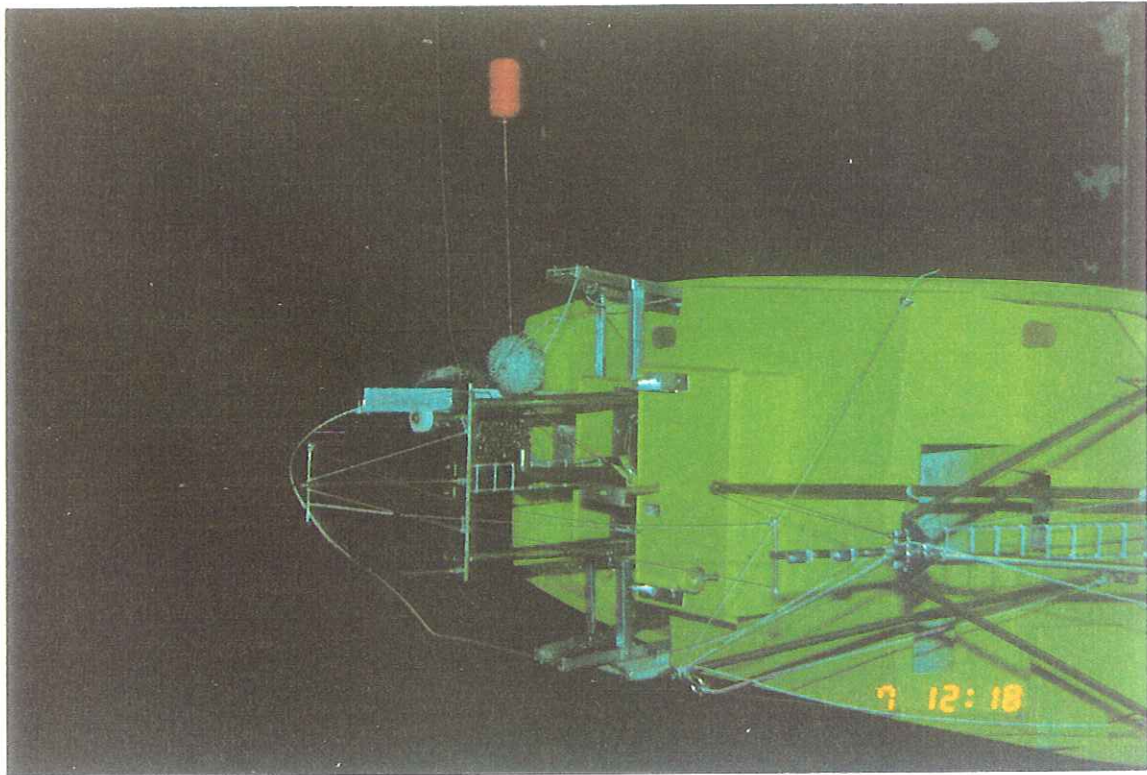
Figure 8. Westhaven model on the tank bottom.  
Port liferaft released from galley roof and painter fouled by cod end

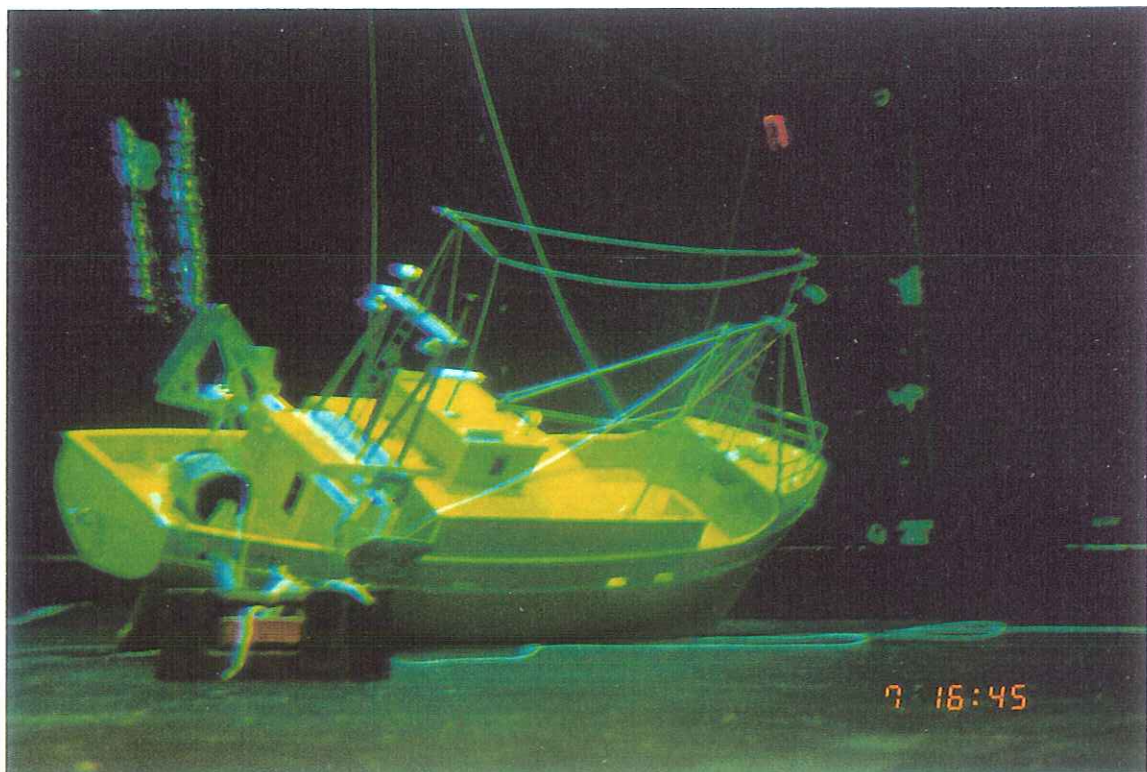
On the Westhaven model one liferaft was stowed on the shelter in front of the wheelhouse. While this location was less encumbered by local structure, and there was no hindrance to canister deployment, the failure rate due to painter fouling was 29%. This is twice the painter fouling rate for the liferafts on the galley roof.

Figure 9. Westhaven model on the tank bottom.  
Liferaft released from shelter roof in front of wheelhouse, and passed through forward tripod mast.

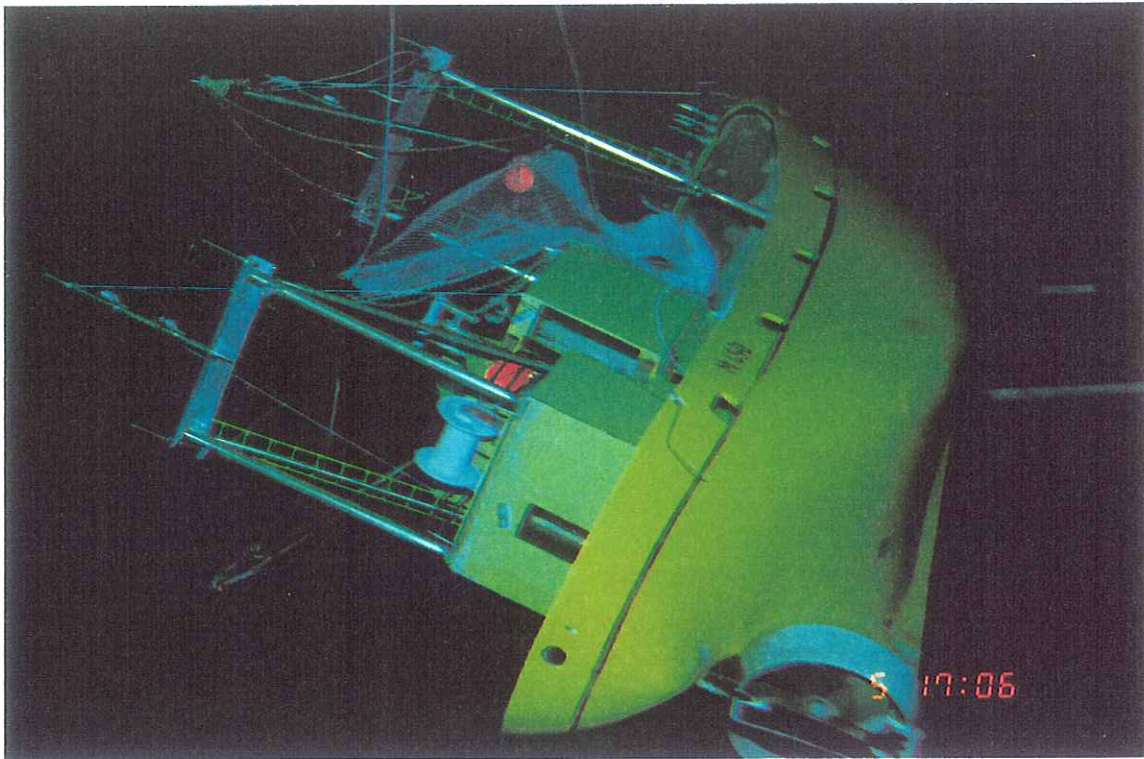
In some notable instances a liferaft canister was prevented from floating free of the model because it became fouled against the structure, for example the aft face of the wheelhouse or adjacent guardrails, or in the trawl net.

Figure 10. Beam trawler model on the tank bottom. Liferafts released from forward on galley roof. Port raft fouled in starboard trawl. Starboard canister jammed by railings.

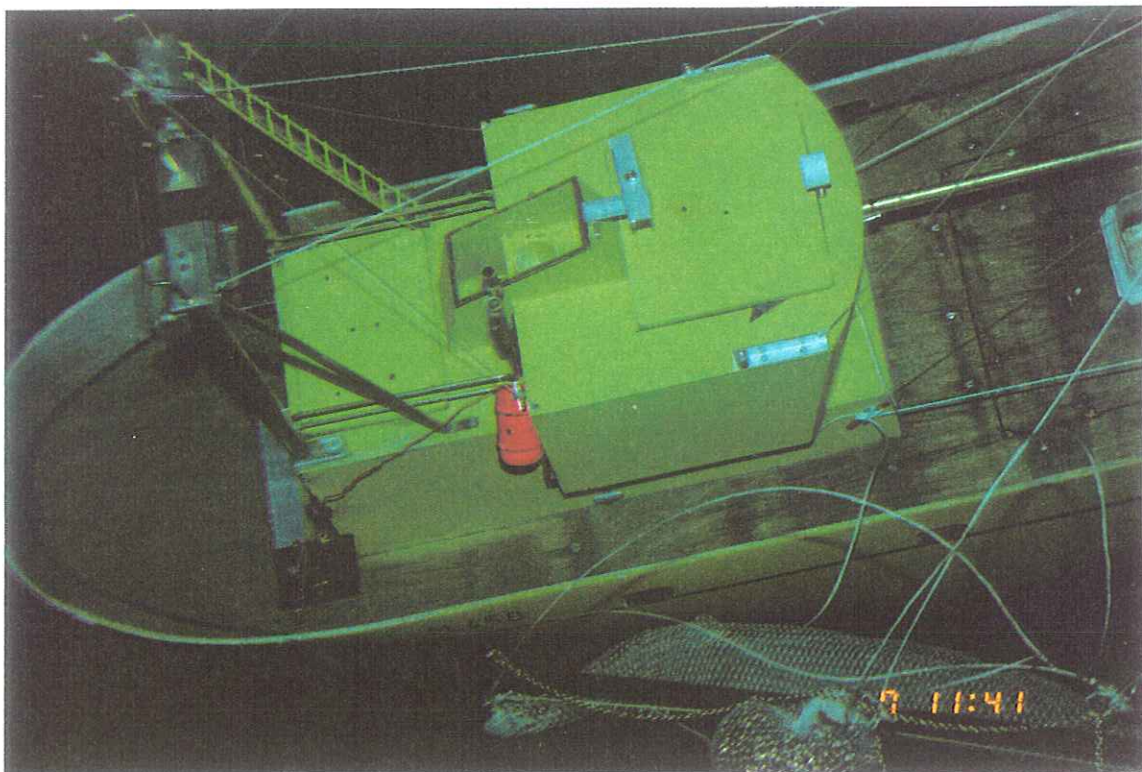
Figure 11. Beam trawler model on the tank bottom. Liferafts released from brackets outboard of galley. Starboard canister jammed in wheelhouse door.

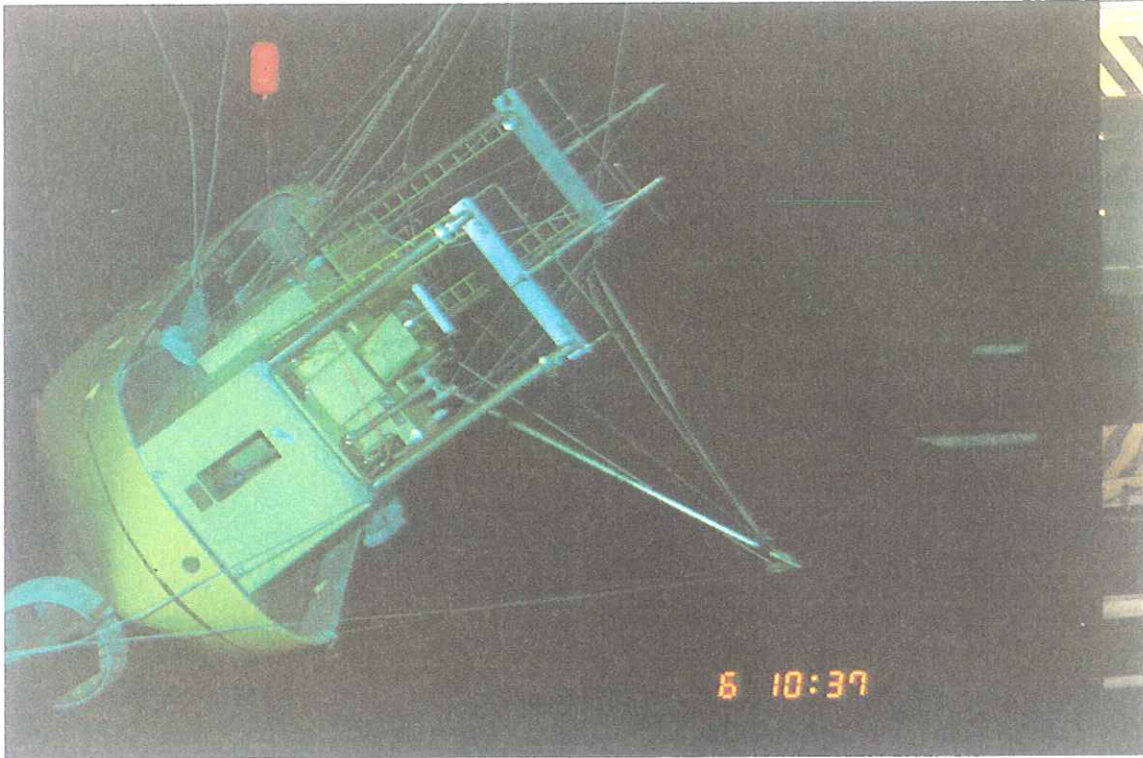
Figure 12. Beam trawler model on the tank bottom. Liferafts released from aft on galley roof. Starboard painter fouled on port trawl bridle.

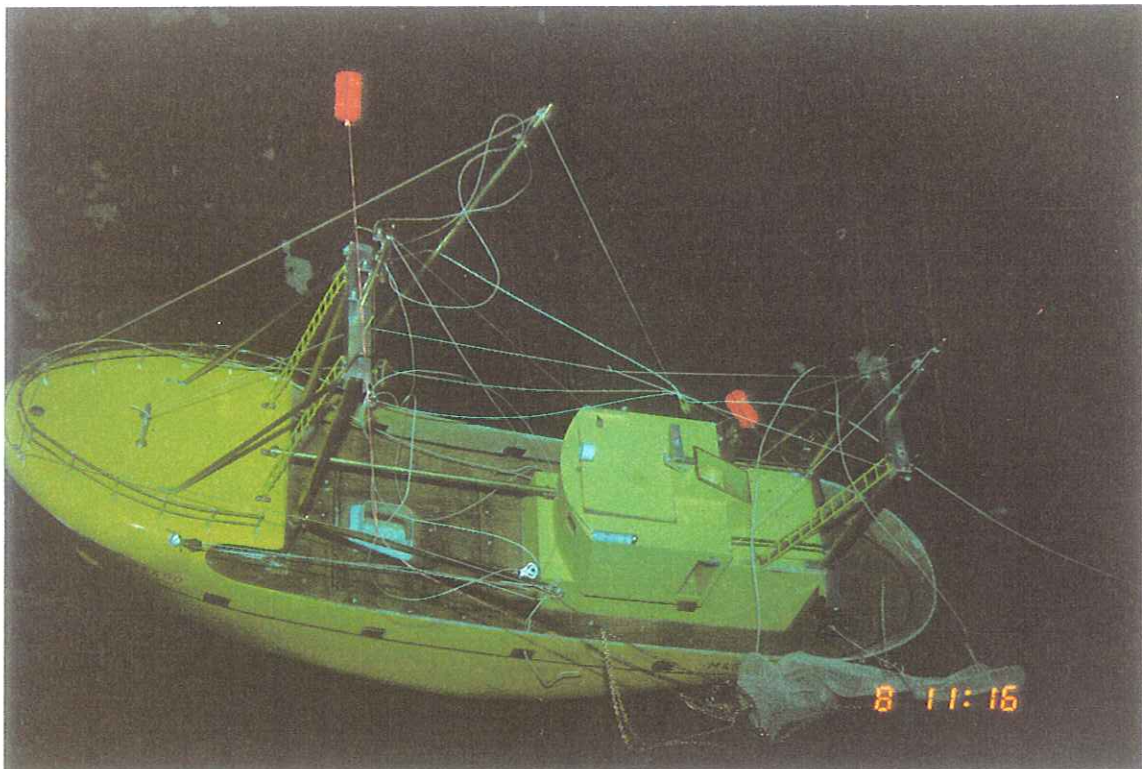
Stowage of the liferafts outboard aft of the galley resulted in a 53% failure rate. On all but one occasion the liferaft located on the low side at release failed to deploy. Conversely, on all but one occasion, the liferaft on the high side deployed successfully.

Figure 13. Beam trawler model on the tank bottom. Liferafts released from brackets outboard of galley. Starboard painter fouled on aft gantry. Port painter fouled on port boom, trawl warp and tickler chains.

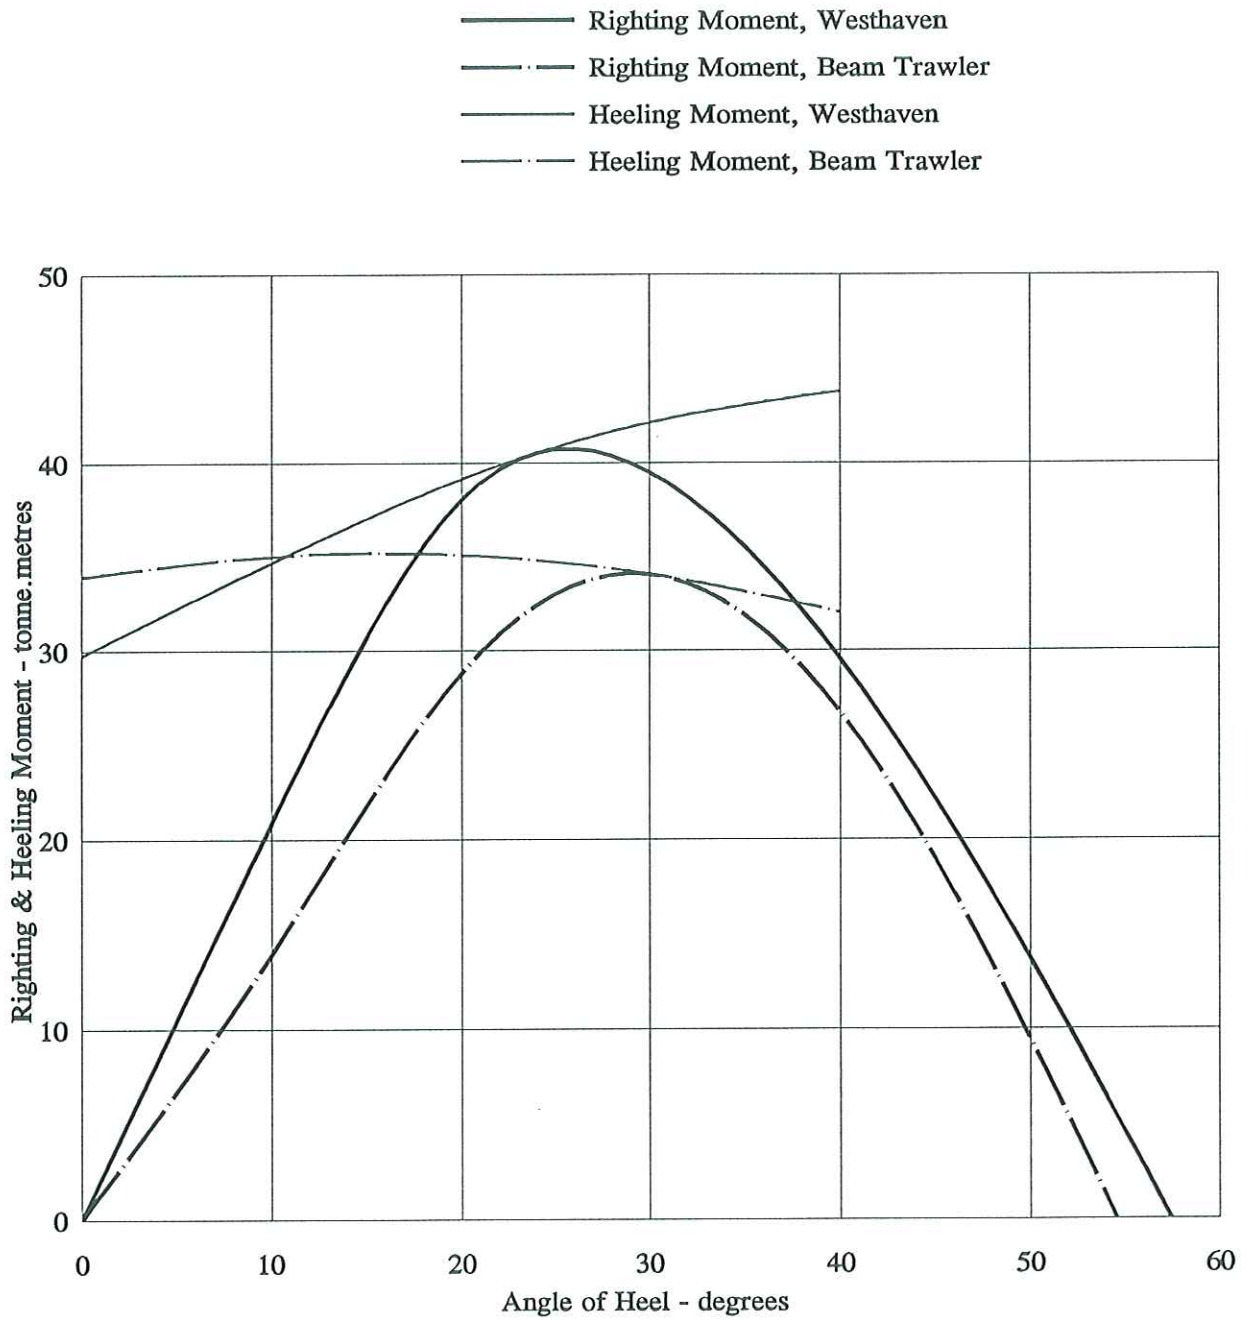
Figure 14  
An Illustration of the Heeling Moments Required to Capsize  
with Constant Warp Tension

Figure 14 presents simple estimates of the heeling moments required to capsize the two vessels represented in these tests by hauling on their trawl warps. For the beam trawler the lead is assumed to be at the outboard end of the horizontal boom, and for Westhaven at the gallows. The effect of the applied load on the effective VCG and GZ have been neglected in this simple analysis, which takes account only of the movement of the warp lead position with heel angle. The beam trawler would capsize at about 30 degrees and the heeling moment remains virtually constant because of the large transverse lever of 10.9 metres. The tension in the trawl warp would be about

3 tonnes. Westhaven would capsize at about 24 degrees with the heeling moment increasing with heel angle because of the relatively high position of the gallows block. With the gallows block 3 metres off the centreline, the trawl warp tension would be about 10 tonnes, as suggested in the MAIB report.

In both instances the trawler crew would have little indication that they were heeling the vessel to the point of capsize since, at lower heel angles, the GZ curves are virtually linear and the heel angle would increase slowly as the warp tension was increased, until the point of capsize.
