WOLFSON UNIT

Report No. 1732

Research Project 524

The Parameters Affecting the Survivability of Small Passenger Vessels in Collisions

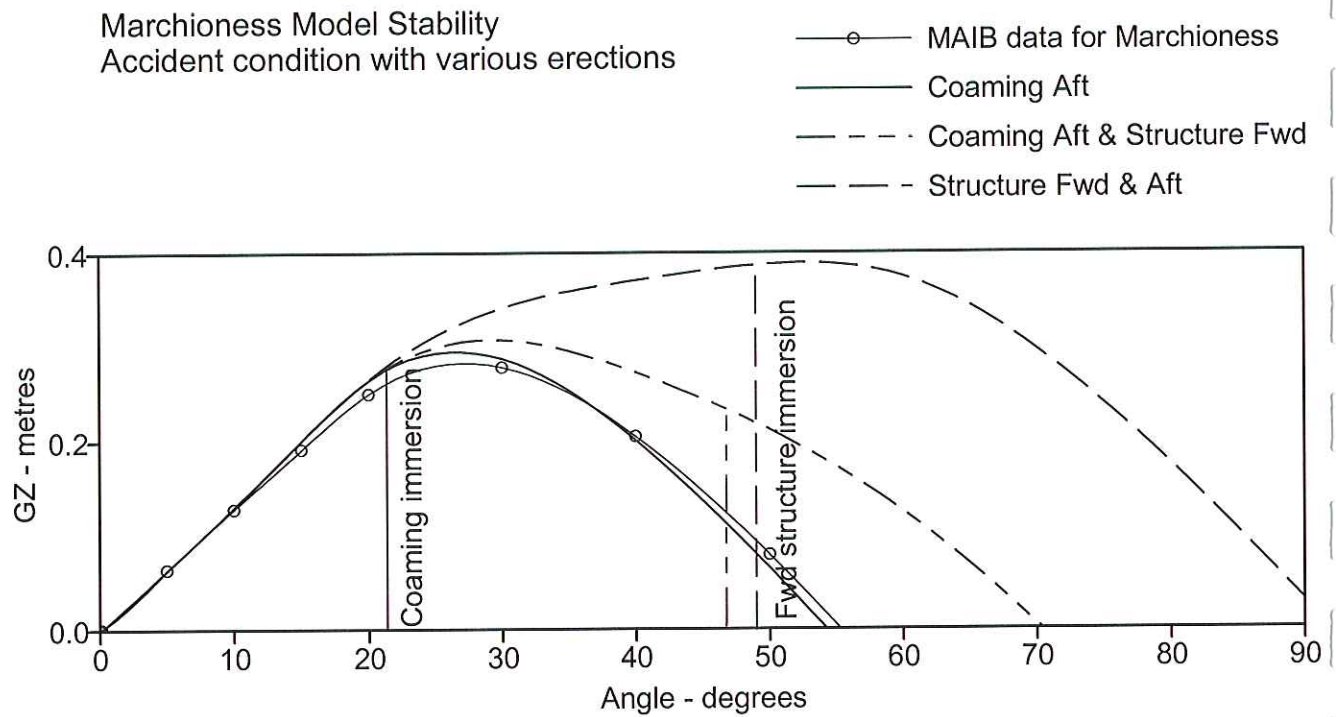
Figure 7 Stability curves for the Marchioness

Principal dimensions of the vessel are presented in Table 1, a drawing in Figure 4, and the stability characteristics for each configuration tested are presented in Figure 7.

Comparison of the stability curves presented Figure 7 and Figure 9 show some common parameters and some highly variable ones. For example, Marchioness and the wider vessel with a high KG have similar maximum values of GZ, while the catamaran has a much larger value. The wider vessel with the low KG has a similar range of stability to the catamaran but still with a much lower maximum KG. It was hoped that these selective differences would assist in the identification of the most influential characteristics. A summary of the stability characteristics is presented in Table 2.

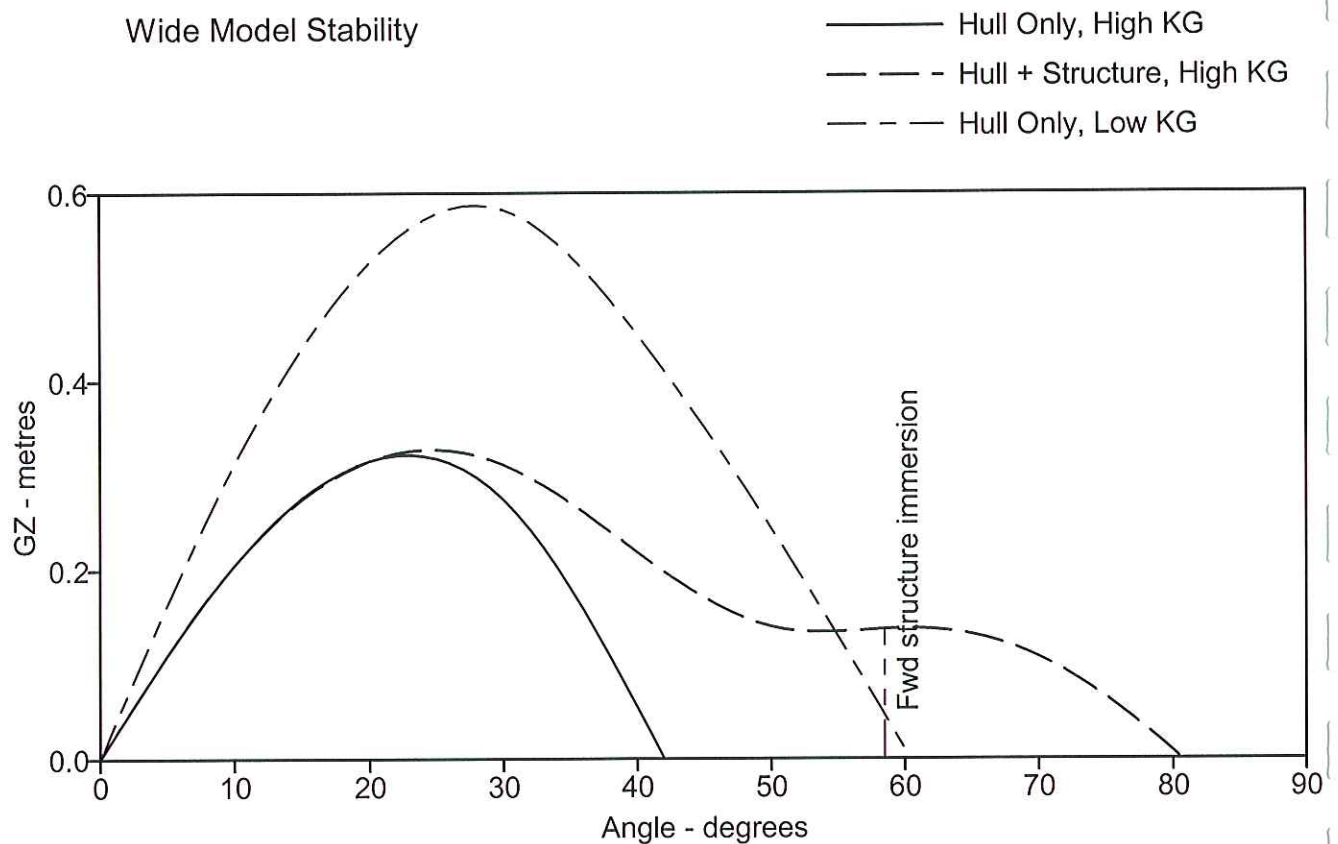
Figure 8 Stability curves for the wider vessel

Principal dimensions of the vessel are presented in Table 1, a drawing in Figure 5, and the stability characteristics for each configuration tested are presented in Figure 8.

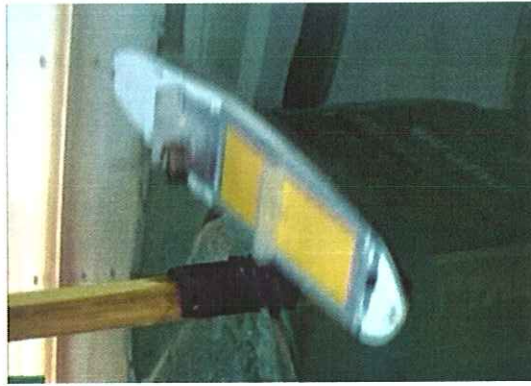
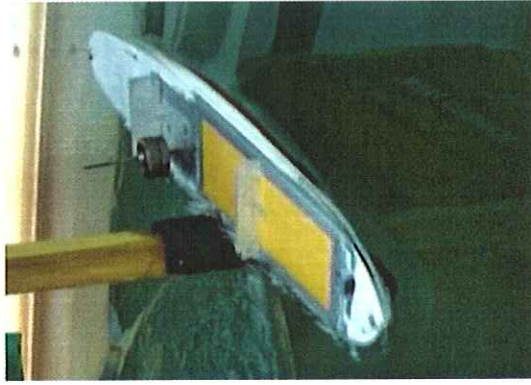
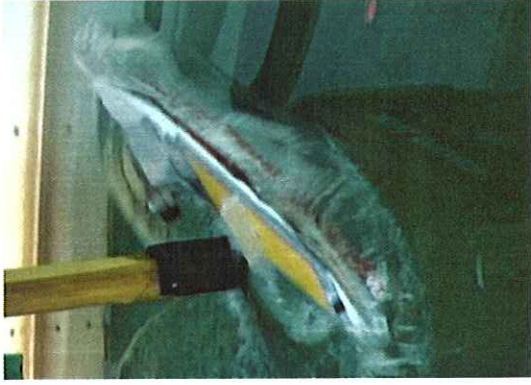
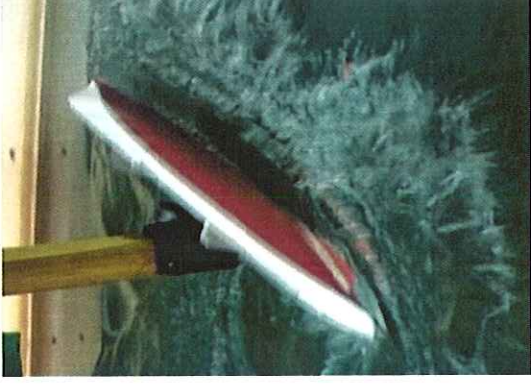
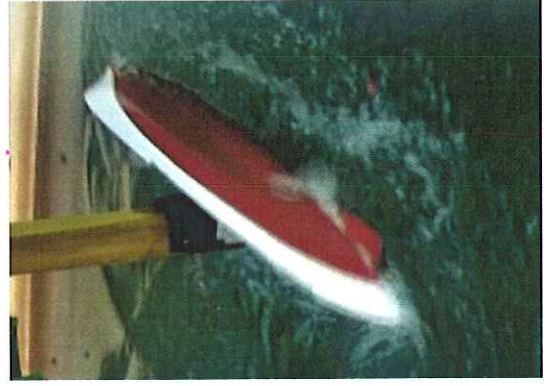
Figure 11 Marchioness – Run No. 31, Collision speed – 6 knots

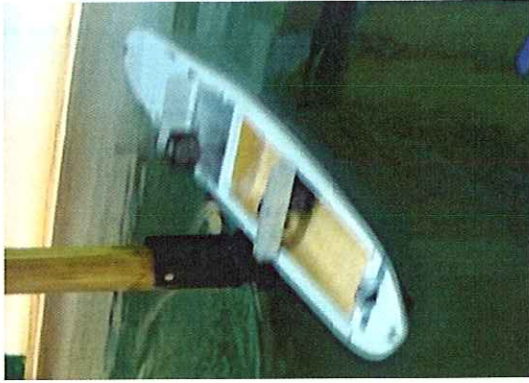
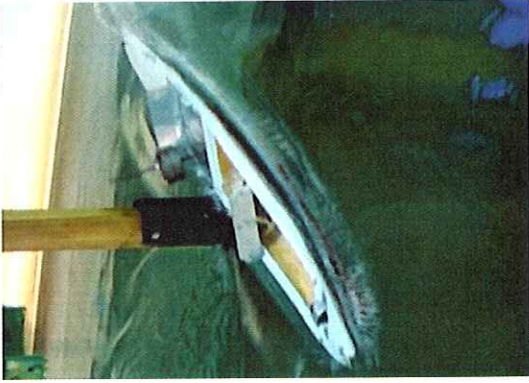
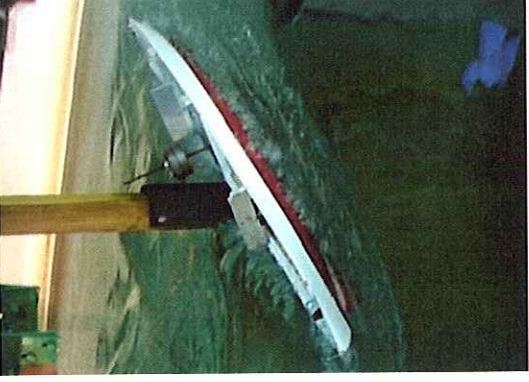
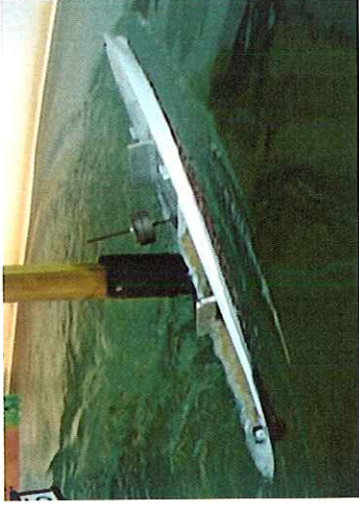
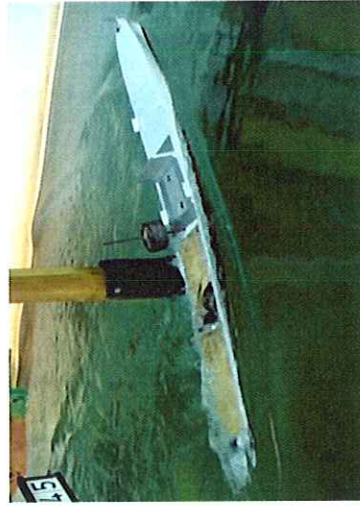
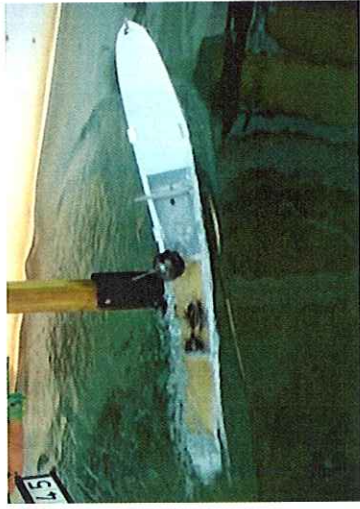
Figure 12 Marchioness – Run No. 145, Collision speed – 4.5 knots

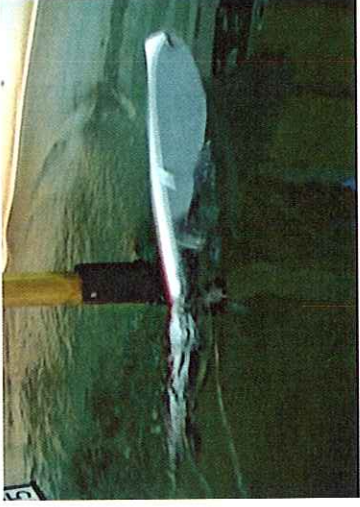
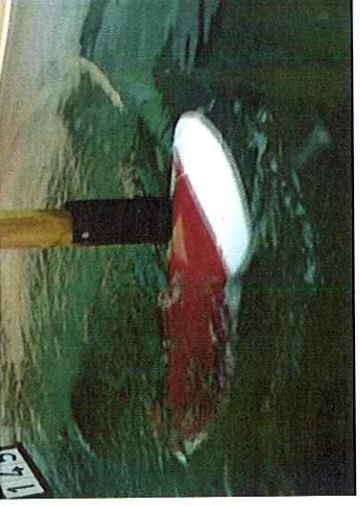
Figure 13 Marchioness – Run No. 128, Collision speed – 5.5 knots

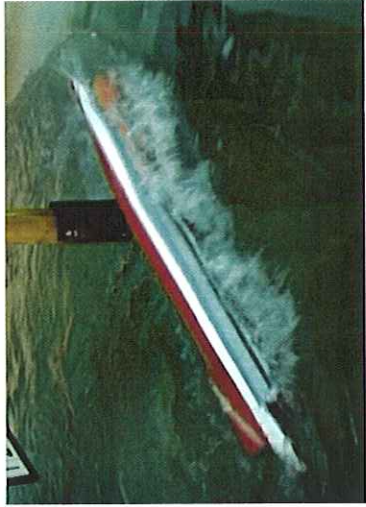
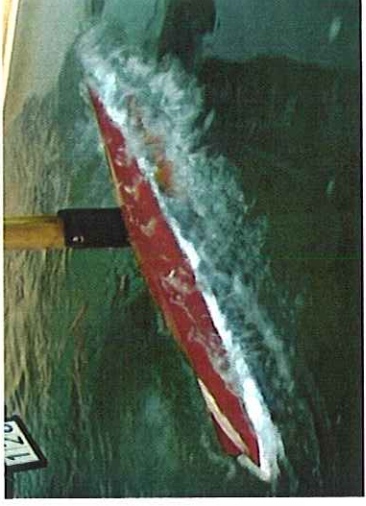
Figure 14 Marchioness – Run No. 134, Collision speed – 4.5 knots

For the Marchioness the results were less clearly defined. With the superstructure fitted all capsizes were away from the strut, although not necessarily because the strut impacted the superstructure. See Figure 14. Without superstructures there were capsizes in both directions. It appeared to be largely dependent on whether the pressure wave rose above the deck edge. This in turn was influenced by the orientation and point of impact. For example, in a collision of type B2, the model rotated rapidly in yaw, the bow being pushed ahead of the strut and generating a large wave that could overwhelm the deck forward and result in a capsize away from the strut. The lack of consistency in these events suggests that quite small differences in orientation or impact point can make dramatic differences to the balance of forces and hence the behaviour.

Impacts at different points along the hull result in different yaw rates, and these can have a strong influence on the behaviour, particularly in the quasi-static phase. Comparison of Figure 11 and Figure 14 illustrates the effects of yaw on the Marchioness model. In Figure 11 the model was struck beam-on amidships and pushed sideways without yawing. It capsized very rapidly towards the strut. In Figure 14 the model was struck aft of midships from the stern quarter, as was the case in the Marchioness incident. It capsized away from the strut, after yawing to a beam-on attitude. The difference appears to be that, in the latter case the stern is pushed through the water much faster than the bow, and the pressure wave is concentrated well aft. The wave rises above the deck edge and the roll then increases rapidly. In the former, beam-on case, the pressure wave is distributed along the full length of the model, and this appears to generate sufficient buoyancy to roll the model towards the strut.

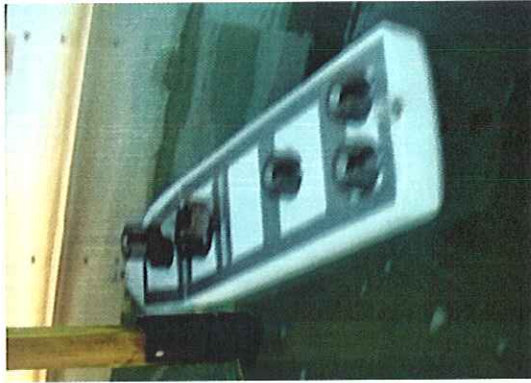
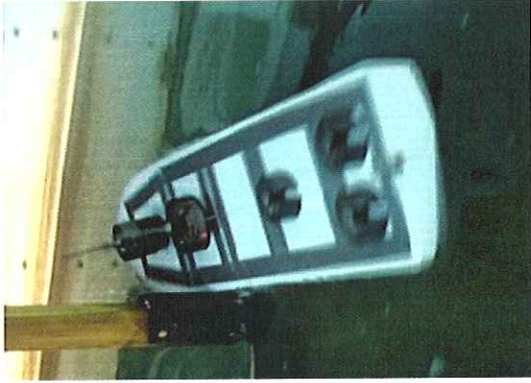
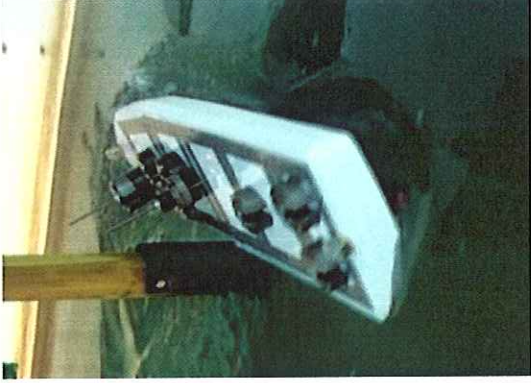
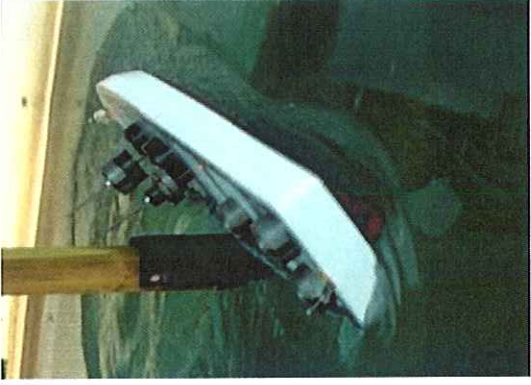
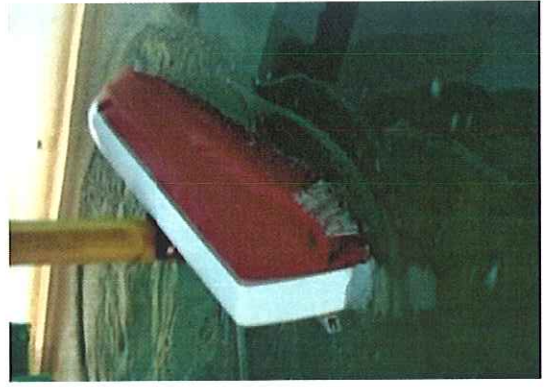
Figure 15 Wider Vessel, High Centre of Gravity - Run No. 88, Collision speed – 4 knots

There is clear evidence from the tests that, for a given vessel configuration, increased stability provides increased resistance to capsize. Comparison of Figure 15 and Figure 16 reveals very little difference between the capsize sequences and so it can be concluded that their capsize mechanisms are the same. Figure 15 is for the lower stability condition, where the critical speed was 4.5 knots. Figure 16 is for the higher stability condition and the critical speed was 6 knots. The difference between the test configurations is merely that ballast weights were relocated to reduce the height of the centre of gravity. The GM increased by 51%, the maximum GZ by 83%, and the range of stability by 43%.

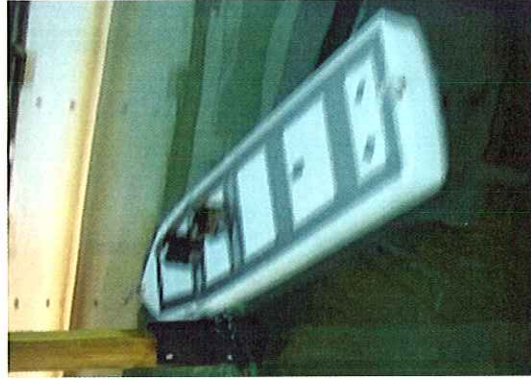
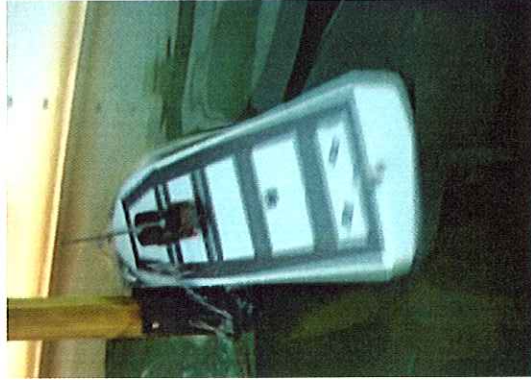
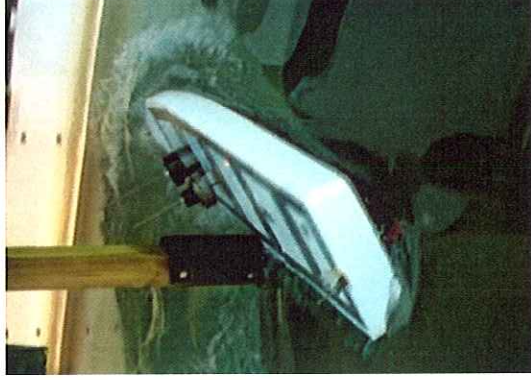
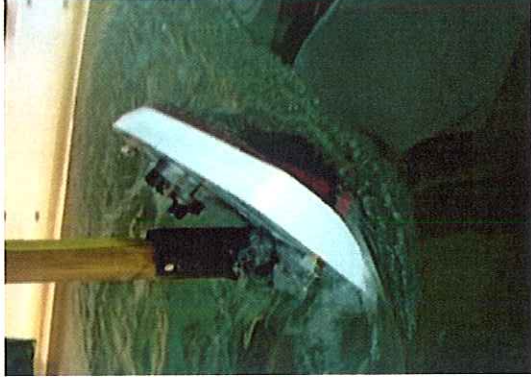
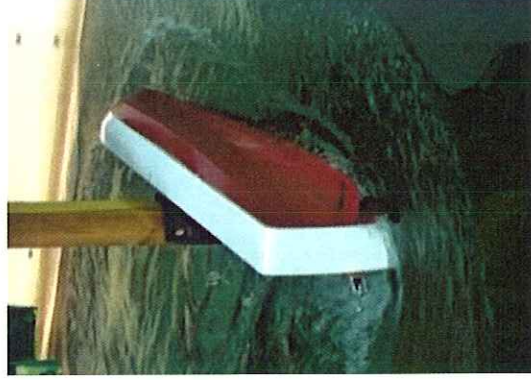
Figure 16 Wider Vessel, Low Centre of Gravity – Run No. 123, Collision speed – 6.5 knots

Figure 16 and Figure 17 show the wider monohull exhibiting rapid rolls towards and away from the collision. The different behaviour is believed to result primarily from the presence of the superstructure

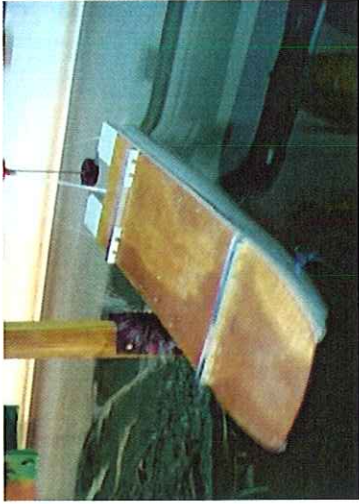
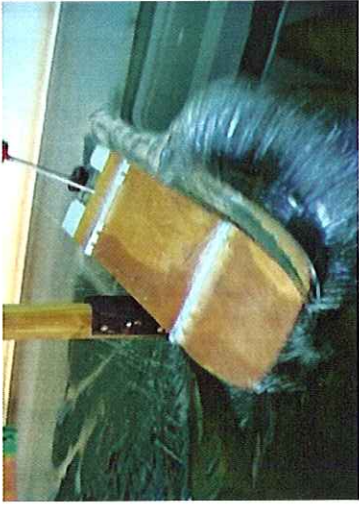
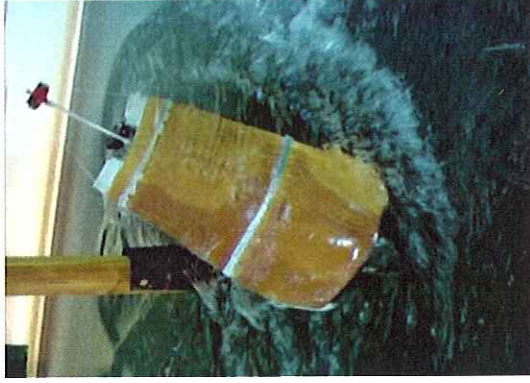
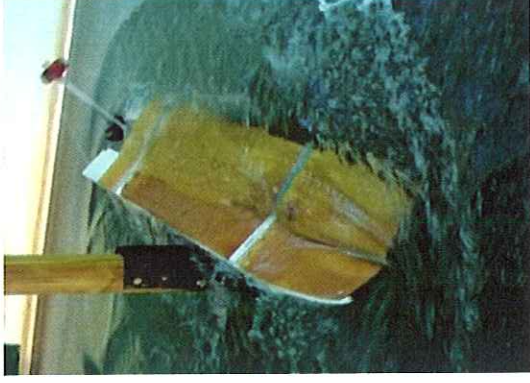
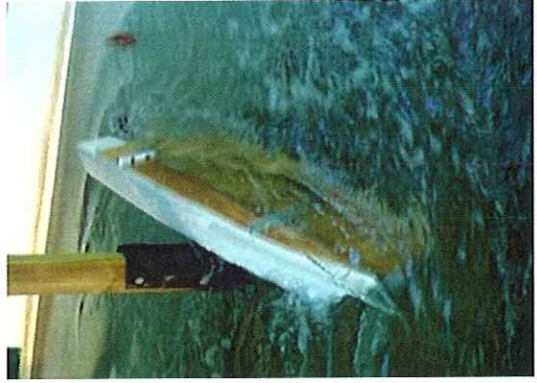
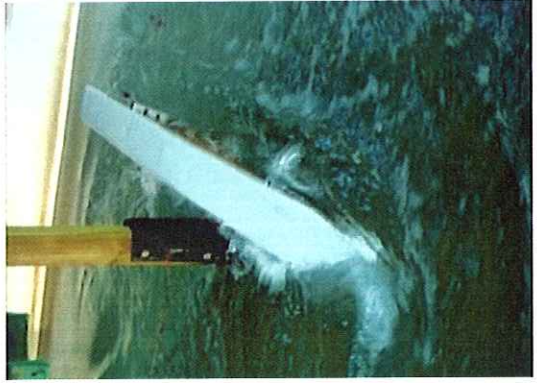
Figure 18 Catamaran – Run No. 174, Collision speed – 6 knots

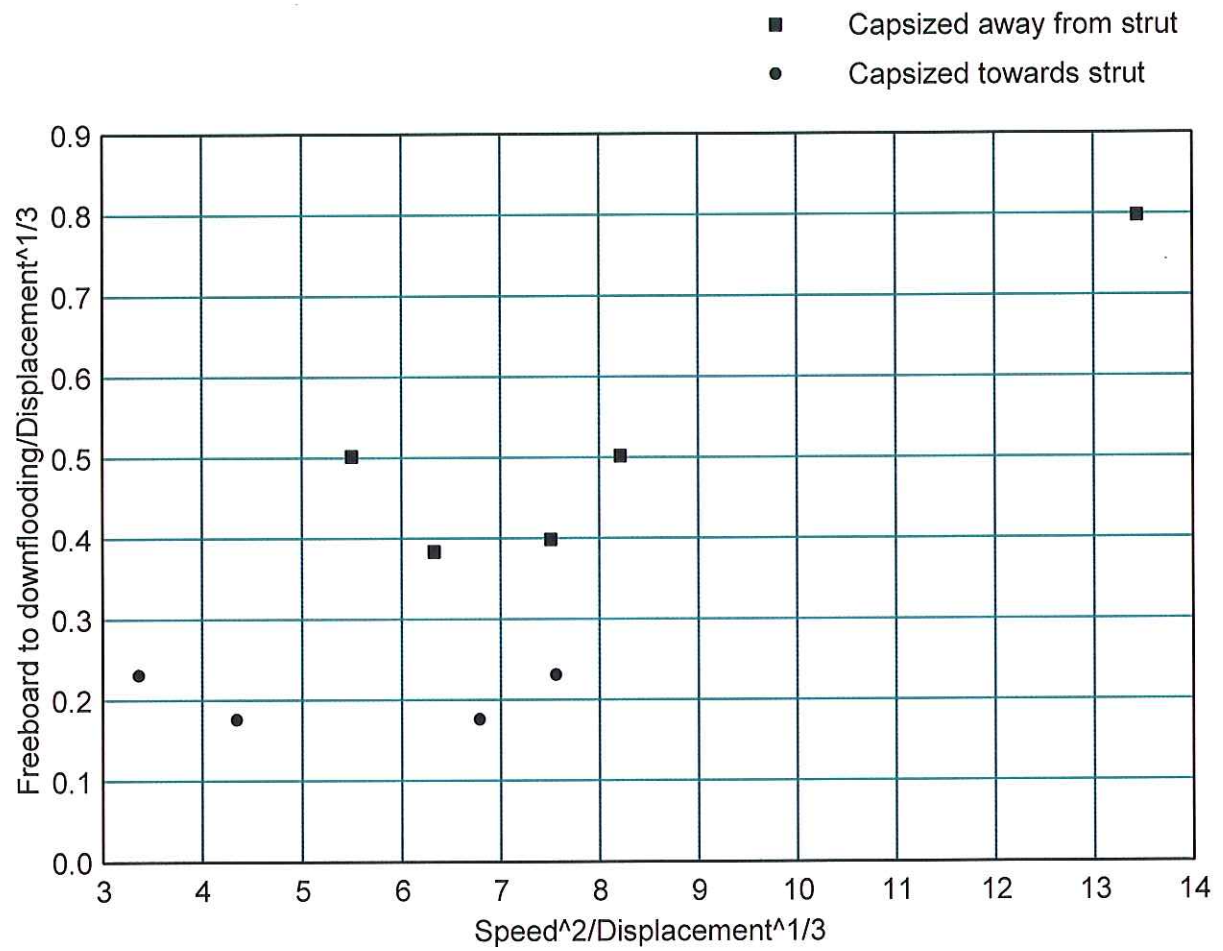
Figure 20 Variation of critical capsize speed with freeboard
