DEPLOYMENT OF LIFERAFTS FROM CAPSIZED OR SINKING VESSELS

Sea Australia 2000, Sydney, 1 to 3 February 2000

Barry Deakin, Wolfson Unit for Marine Technology & Industrial Aerodynamics,
University of Southampton, SO17 1BJ, UK.

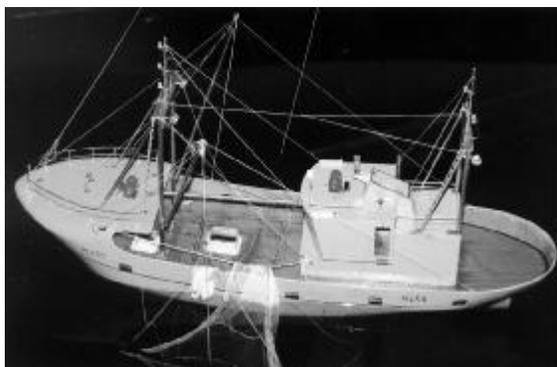
Figure 1. Beam trawler model prepared for testing with the port trawl raised, and liferafts located on the focsle and wheelhouse.

The beam trawler model had been constructed for a previous programme of work conducted for the Marine Accident Investigation Branch in 1993. That work involved tests to study the behaviour of the vessel during capsize and sinking in a number of different scenarios [3]. The model was intended to be representative of a typical beam trawler of about 24 metres overall length, and similar to the F.V. Pescado which capsized and sank with the loss of all six crew in 1991 [4]. The second model was based on the Scottish F.V. Westhaven which capsized and sank with the loss of all four crew in 1997 [5].

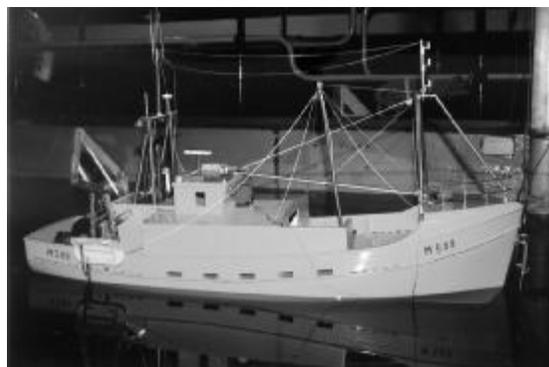
Figure 2. Westhaven model prepared for testing, with liferafts on the focsle and shelter.
